ANNUAL REPORT

2022

NPDES NO. CA0048054
ORDER NO. R3-2022-0014

2022 Summerland Sanitary District (SSD) Outfall Assessment Post Operations Report

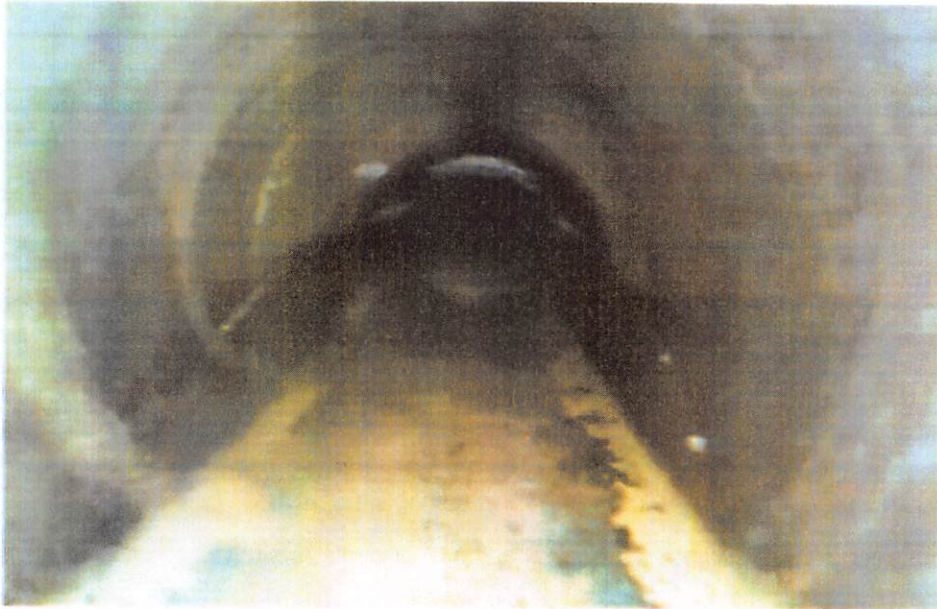
After determining that lining was hydraulically viable, MPM recommended an internal visual inspection of the outfall. The internal inspection performed 11/02/2021 by SSD showed that the pipe interior was in good condition from the manhole for the initial 80-feet but that internal corrosion byproduct buildup starting at the tidal interface, approximately 90-ft seaward of the manhole, decreased the ID of the outfall significantly making further inspection unviable.

Figure 1: November 2, 2021 / 08:35 High Tide Line at +5.7' MLLW

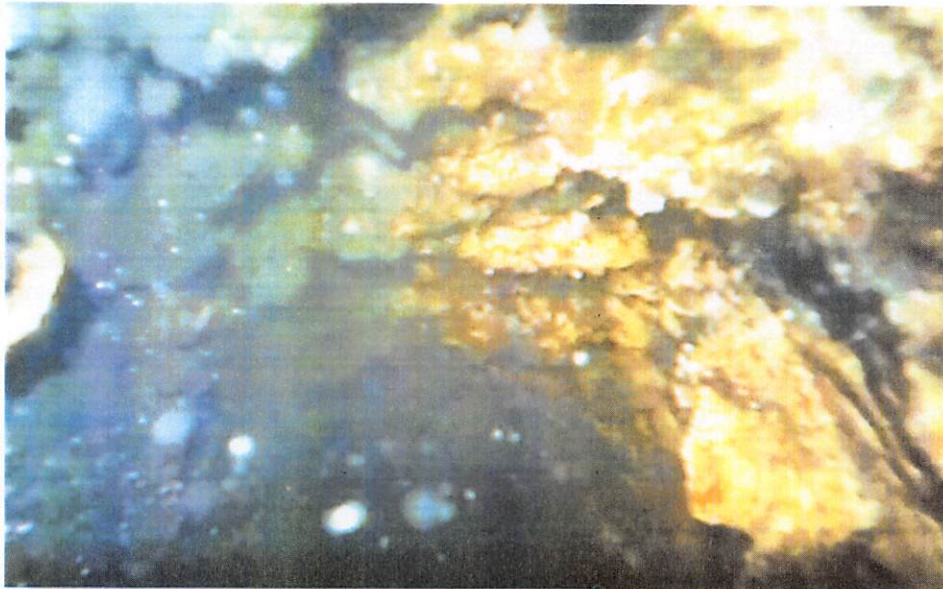
Additionally, the volume of corrosion byproduct was deemed significant enough that cleaning from the shore/manhole end posed an unacceptable risk of plugging the outfall with the byproduct.

Figure 2: Severe Corrosion Byproduct Buildup at End of Survey

Based on the internal inspection findings and the risk of plugging the outfall with shore-based cleaning, it was determined that marine-based operations would be required to assess the viability of lining.

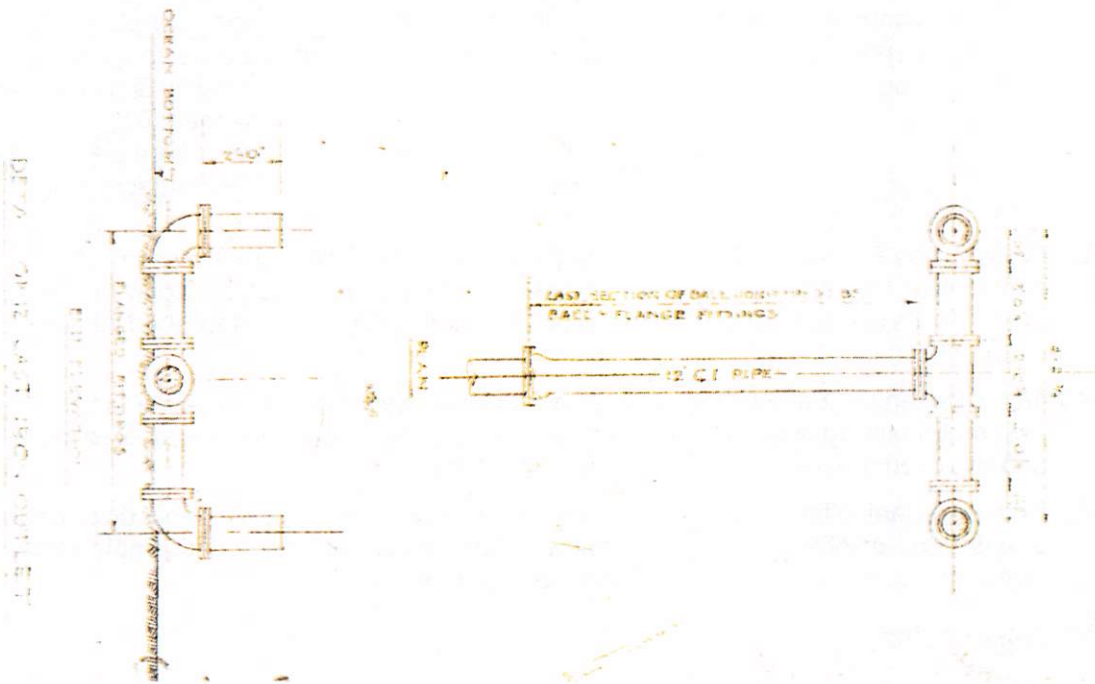
- 4.2.2 Diffuser Inspection – The diffuser tee (Figure 5), was initially cleaned of marine growth with a diver-held “water blaster” regulated down to 3,000 psi to prevent damage until further inspection could be performed. The cast iron tee exhibited external corrosion however cleaning operations did not further damage the pipeline end assembly. A portion of the outfall piping was cleaned at 12 o’clock (top of pipe) and the piping was found to be in good condition except for two through-wall defects just inshore of the end flange, likely caused by wear from the pipeline end marker buoy chain before it was relocated to the clump weight.

Figure 5 Diffuser Tee Sketch

PRELIMINARY DIFFUSER INSPECTION FINDINGS		
Task No.	Task Description	Findings
1	Diffuser tee to outfall pipe flange diameter (19")	~61" Circ (19" dia.)
2	Diffuser tee flange bolt quantity (12)	12
3	Nut size (1-1/2")	1-5/16
4	Inspect the diffuser pipe components' OD for corrosion. If through-wall defects are not present, evaluate with pit gauge and UT if practical and record representative maximum pit depth and minimum UT WT.	1/8-3/16" pits (no through-wall defects)
5	Inspect diffuser discharge riser ID's for pitting and overall condition. Does it appear structurally competent for reattachment of the diffuser?	1/8-3/16" pits (no through-wall defects), one riser plugged
6	Inspect balance of diffuser and adjacent joint of outfall pipe.	2 ea. through-wall defects @ pipeline end flange. Likely due to wear from previous buoy chain attachment.

- 4.6.12 Through-wall Defect Repair – The two through-wall defects identified at the outfall end flange that were likely caused by chain wear were repaired with Splash Zone underwater epoxy.

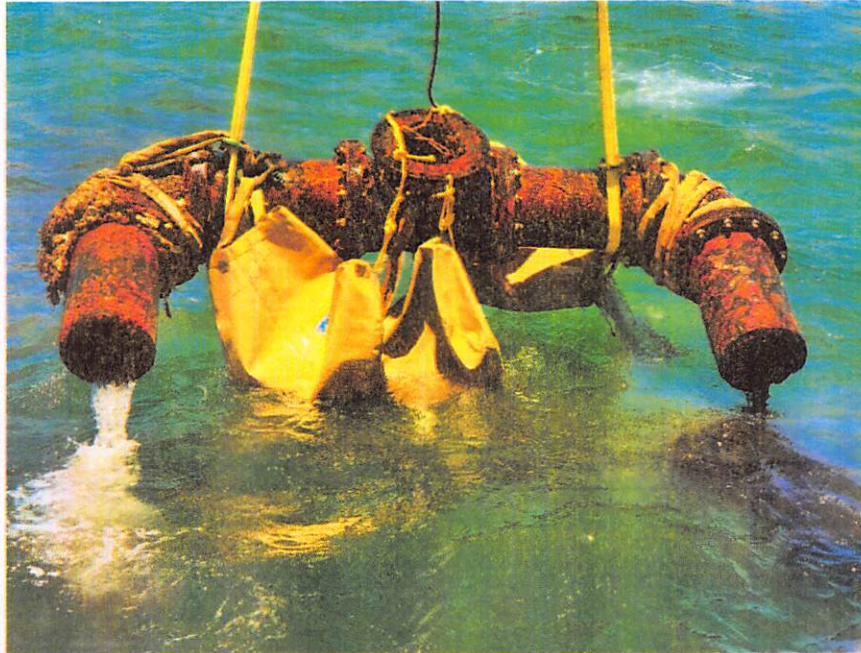
- 4.3.4 Pipeline Diffuser Recovery – Divers recovered the pipeline end diffuser that had been removed previously for further inspection. The downcoast (Carpinteria) side vertical outlet was completely blocked with marine growth.

Figure 6 Diffuser Tee Recovery

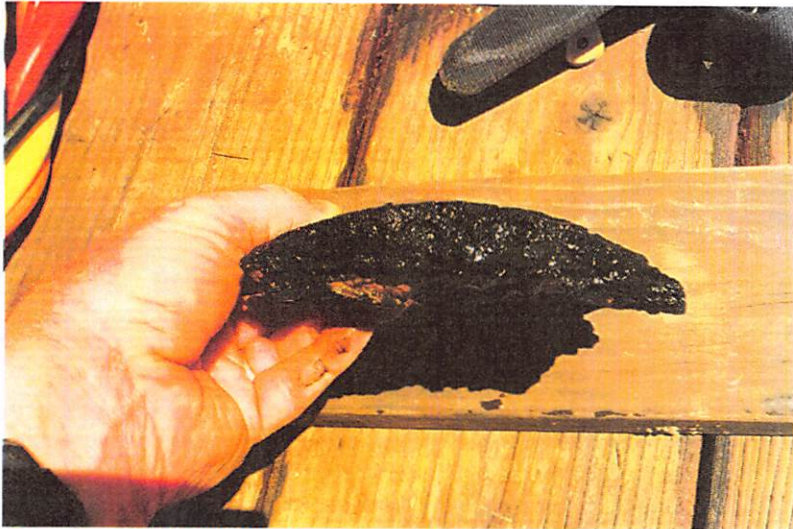
- 4.6.10 Video Inspection Attempt #2 – The video camera was reinstalled into the pipeline and pushed forward with fiberglass rods. At 8’, the camera became stuck once again. Debris from cleaning operations had collected at the bottom of the outfall and were large enough to make the pipe impassible with the video unit. See Figure 9 and 10 Typical Dislodged Material below.

Figure 9: Typical Profile of Dislodged Internal Buildup

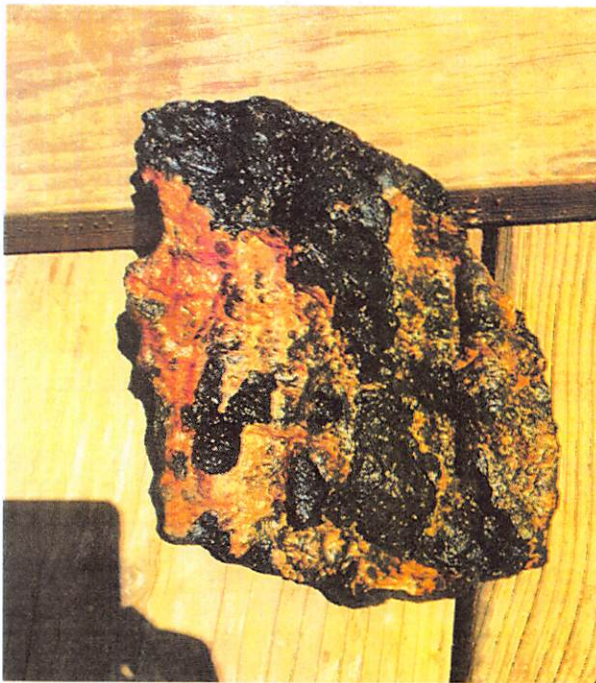
Figure 10: Typical Dislodged Material
