# Summerland Sanitary District News

September 2018

## COLLECTION SYSTEM REHABILITATION PROJECT

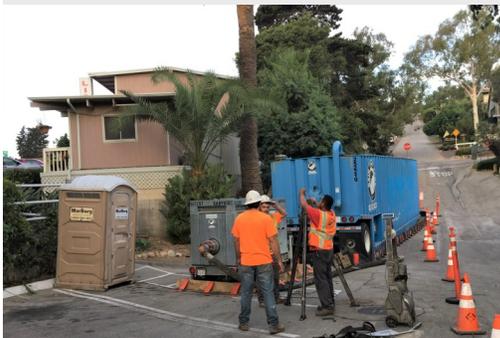
Pre-installation Inspection

In conjunction with our sewer lines, we recently discovered that one of our major lines that runs below Ortega Hill Road between the Sandpiper Liquor Store and the Red Kettle coffee shop's parking lot was failing. What would have been a major disruption and consequently quite expensive years ago, now through modern technology is much simpler and less costly. This past month, on August 27th through August 29th, the District hired Cushman Contracting Corporation to replace the 8-inch diameter cast iron pipe that is encased in a larger 20-inch diameter steel casing pipe that was installed sixty years ago in 1958. As I mentioned through our monitoring inspection use of CCTV video we discovered that many irregularities were visible in the line.

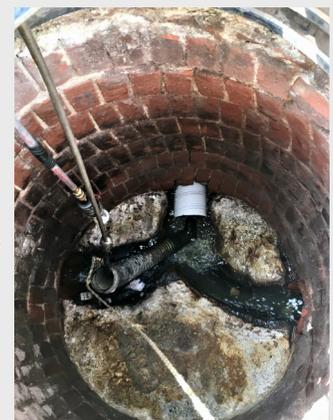
New line installed

The District management researched the replacement project and found that one of our neighboring sanitary districts, Goleta West to be specific, was replacing their broken lines with a new system using PVC spirally wound profile liner pipe. Quite simply, the process involved in our case running a PVC profile strip from one manhole behind the Sandpiper Liquor Store to another manhole in the parking lot next to the Red Kettle coffee shop. Once the strip is run through the entire length between the two manholes, a secondary mechanism is then inserted into the liner which expands the liner to the diameter of the interior old pipe. And lastly the liner, when expanded links itself piece by piece to form a solid pipe. Thus, no excavation was necessary on the major Ortega Hill Road that would have severely disrupted the traffic by us locals as well as the constant overflow of 101 drivers. In addition, the cost although high at roughly \$100,000 was well below what major excavation would have cost.

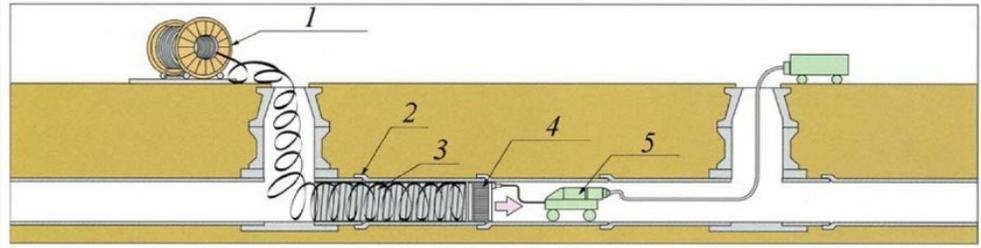
### PVC spirally wound profile liner process

A fragment of sewer pipeline being renovated by spiral-wound technology using a mobile winding machine: 1 – drum with endless profile strip; 2 – host pipe, 3 – liner inside old pipe; 4 – self-propelled winding machine; 5 – mobile device for continuous feeding of an adhesive resin to the locks.
