ANNUAL REPORT

2022

NPDES NO. CA0048054
ORDER NO. R3-2022-0014

2022 Summerland Sanitary District (SSD) Outfall Assessment Post Operations Report

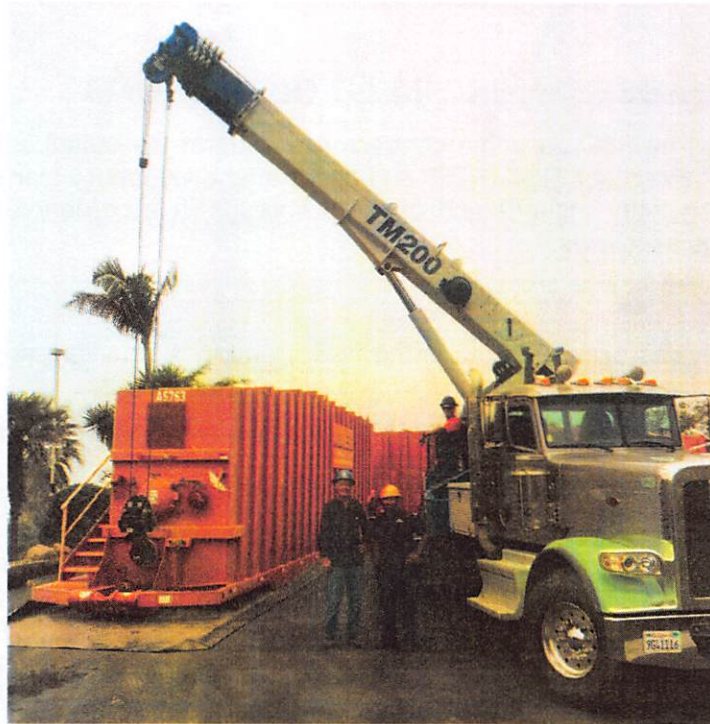
Figure 3: Parking area tankage

- 4.1.2 Tankage Mobilization – Tankage and associated piping were mobilized to the site June 10th 2022, and tankage was filled on June 13th. Two (2) ea. 500-barrel (21,000-gal) temporary holding tanks were located on the asphalt parking area, east of the plant entrance. An intra-tank manifold was installed between the tanks to facilitate operations and fill/drain hose routed to the final retention pond area where 2 ea. 6” pumps were staged. The plumbing allowed for filling the holding tanks from the retention pond via the pumps or to flow from the tankage to the outfall (via the retention pond) to facilitate increasing the discharge flow rates.

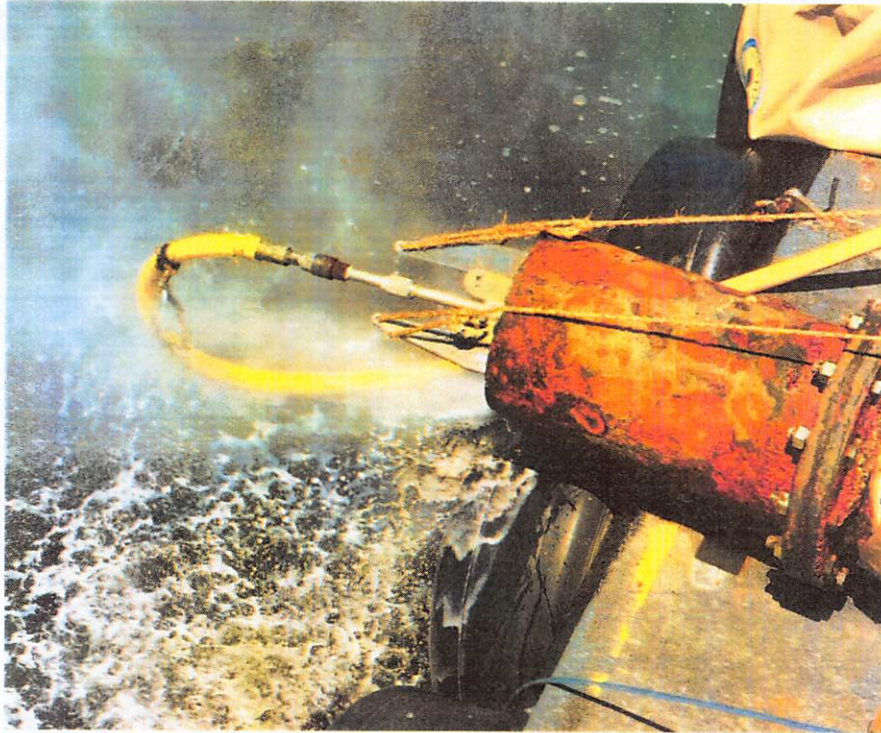
Figure 7: Cleaning Tool Performance Test

- 4.3.5 Waterblast Cleaning Preliminary Tests – Following Tee recovery, the high pressure waterblast cleaning tool was tested inside a vertical riser (positioned horizontally) to determine cleaning effectiveness. Following the field tests, operations were secured and the temporary pipeline end diffuser reinstalled. Divers were released for the weekend to allow for jam skid modifications to be completed.

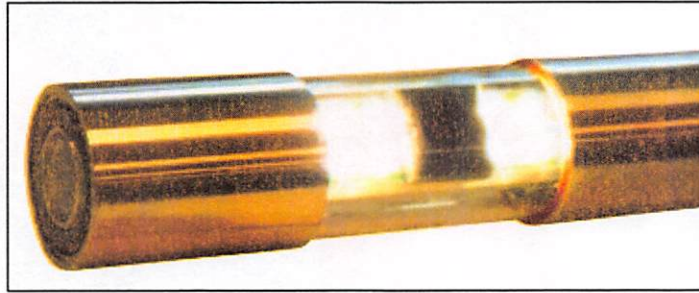
Figure 8: Borehole Camera Body Example

- 4.6.8.1 General Description – The borehole video camera is a cylindrical camera mounted in a centralizing frame with three centralizing “fins”. The unit has a forward facing camera and a second (sidewall) camera that faces perpendicular to the camera body. The cameras rotate as a unit and can rotate 360°. When viewing the sidewall camera image, the offshore end of the pipe is at the top of the screen and the direction of travel is, counterintuitively, at the bottom of the screen.
