ANNUAL REPORT

2024

NPDES NO. CA0048054
ORDER NO. R3-2022-0014

SUBJECT: NPDES Permit No. CA0048054
ORDER No. R3-2022-0014
Annual Report-2024

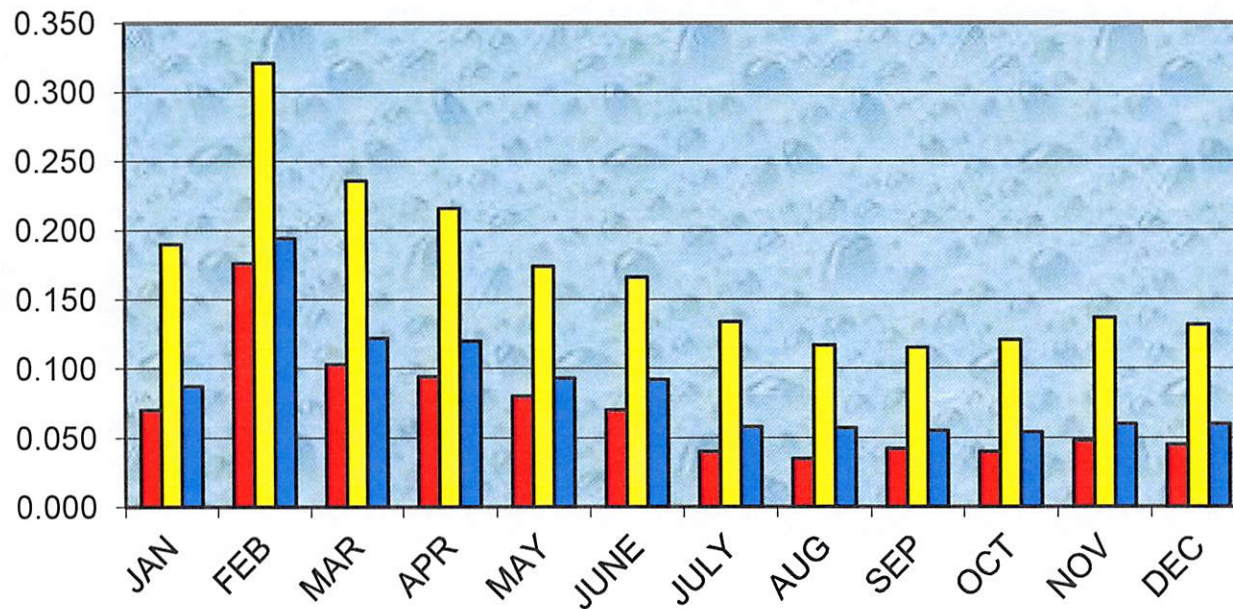
SSD FLOW DATA MGD 2024

Yearly Averages

InstMax	MaxDaily	Avg.Daily
0.116	0.151	0.067

The dry weather Average Daily Effluent Flow was 0.068 MGD for 2024 (approximately 23% of the 0.300 MGD permitted limit). One new sewer service connection was added to the collection system in the past year. The addition is a single-family dwelling. The rate of development in the Summerland Sanitary District service area is and has been,

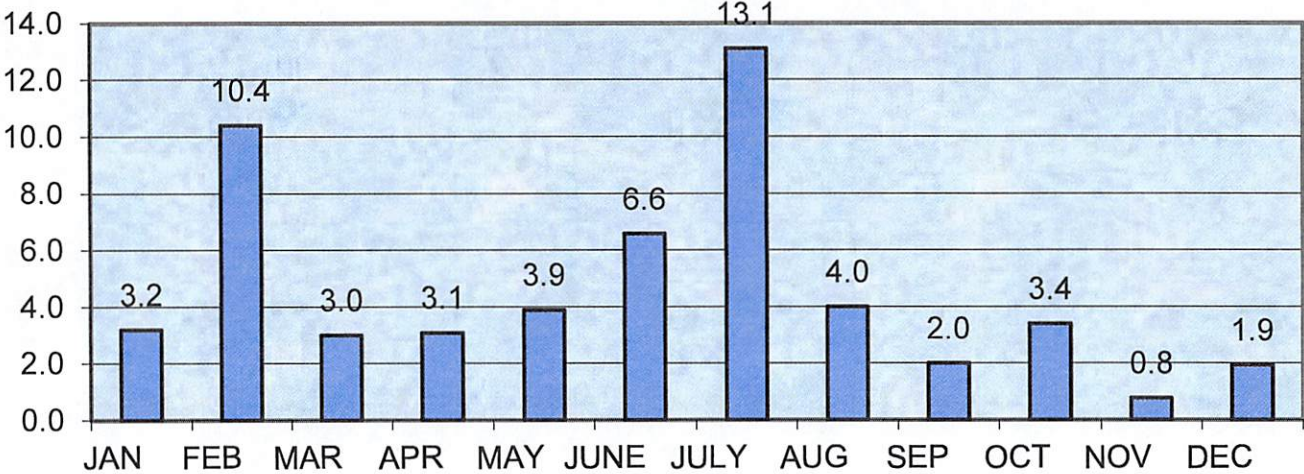
SSD TOTAL COLIFORM 2024

■ T COLIFORM
MPN/100 ML

Any single sample shall not exceed 2300 MPN

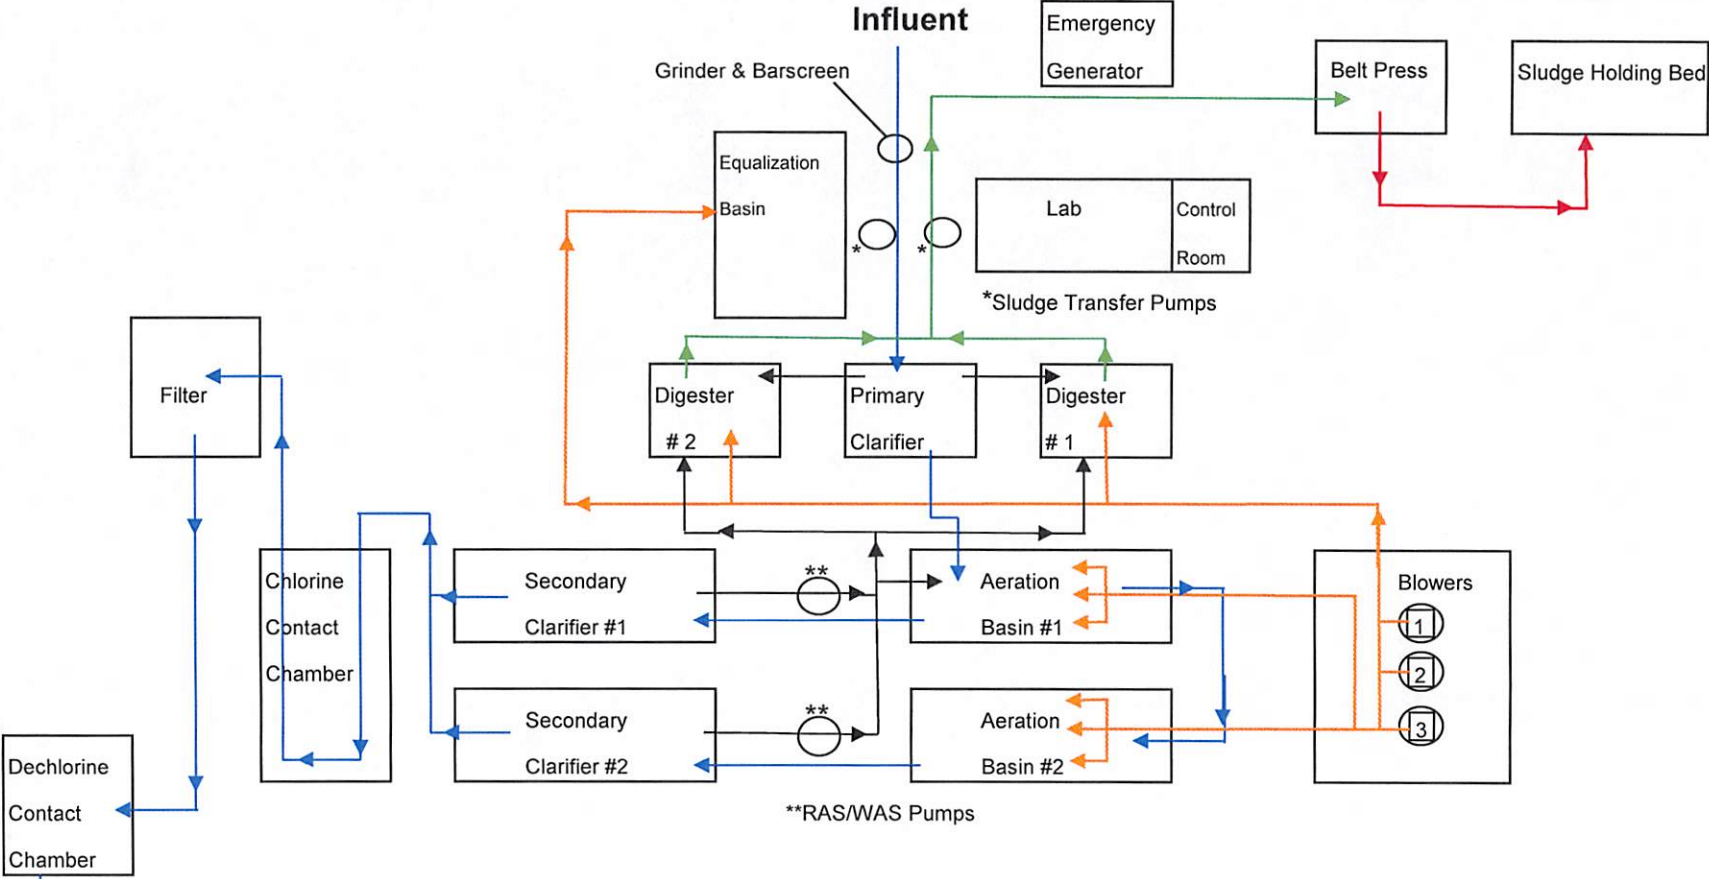
SUMMERLAND SANITARY DISTRICT

Treatment Plant Flow Diagram
 Design Flow .3 MGD
 Average Daily Flow .07 MGD
